ECO PLUS 2 M32 x 2 THREAD

ISSUE 23-01

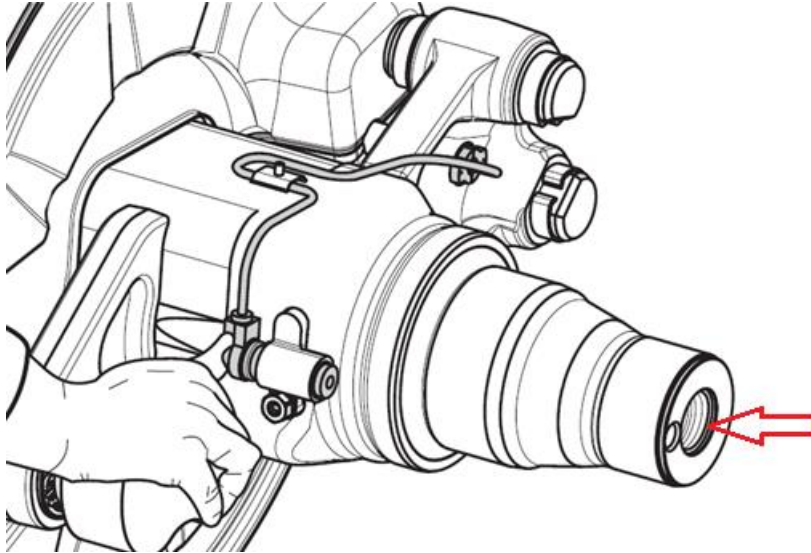
The thread in the axle stub for Eco Plus II axles is a formed thread. As such, a thread tap cannot be applied to repair severe thread damage. In cases where the axle bolt proves difficult to engage with the starting threads, an M32 x 2 thread tap may be used to remove thread debris preventing engagement from the starting 2 – 3 threads only. The remaining threads must not be tapped.

Repair using a M32 x 2 tap is only permitted to be attempted on the first 2-3 threads in the axle bolt hole
